<b>Title:</b> SM100 Overmold	<b>Product:</b> 6460, 6460-20	7 Sept 15
------------------------------	-------------------------------	-----------

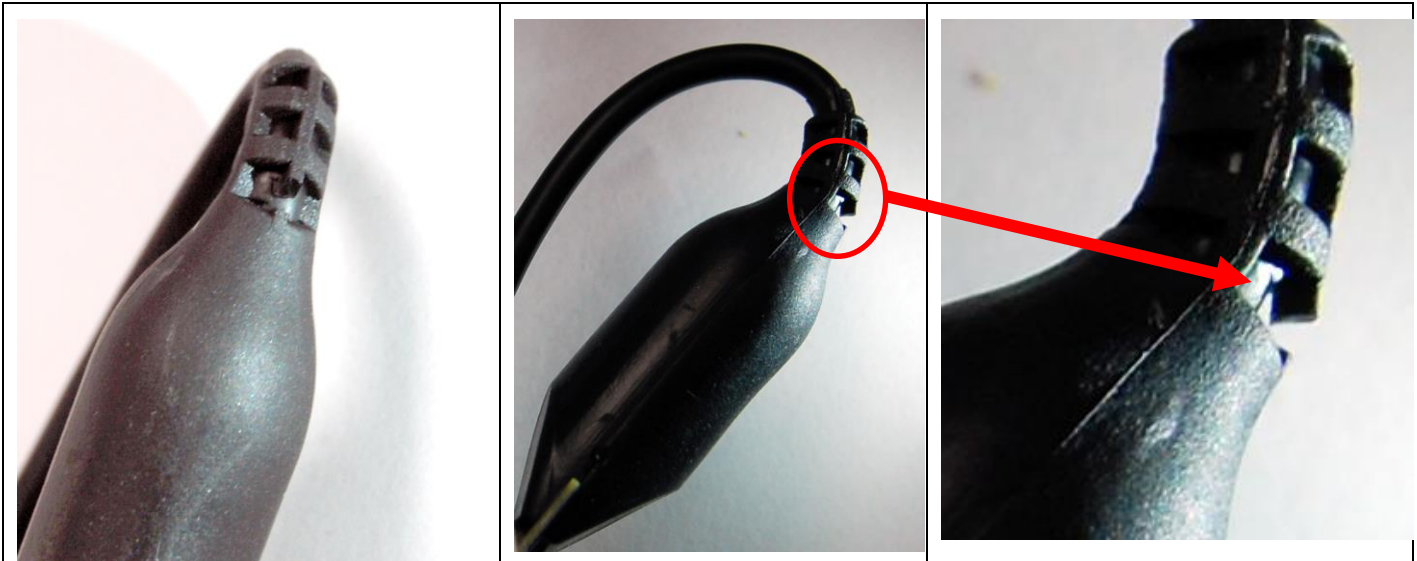
SM100 soil moisture sensors, both 6' and 20' have been found to have improper overmolding. The molded body exhibits cracking especially in the strain relief detail, where the cord exits the body. See example below.

In addition to being visually noticeable the cracking can cause incorrect readings. Unusually high readings, dashes "----", or constant 0 readings may indicate a problem with the sensor.

The manufacturer of the overmolding has been contacted and a corrective action plan is in place to ensure this does not happen again. Devices exhibiting this issue should be returned and replaced.

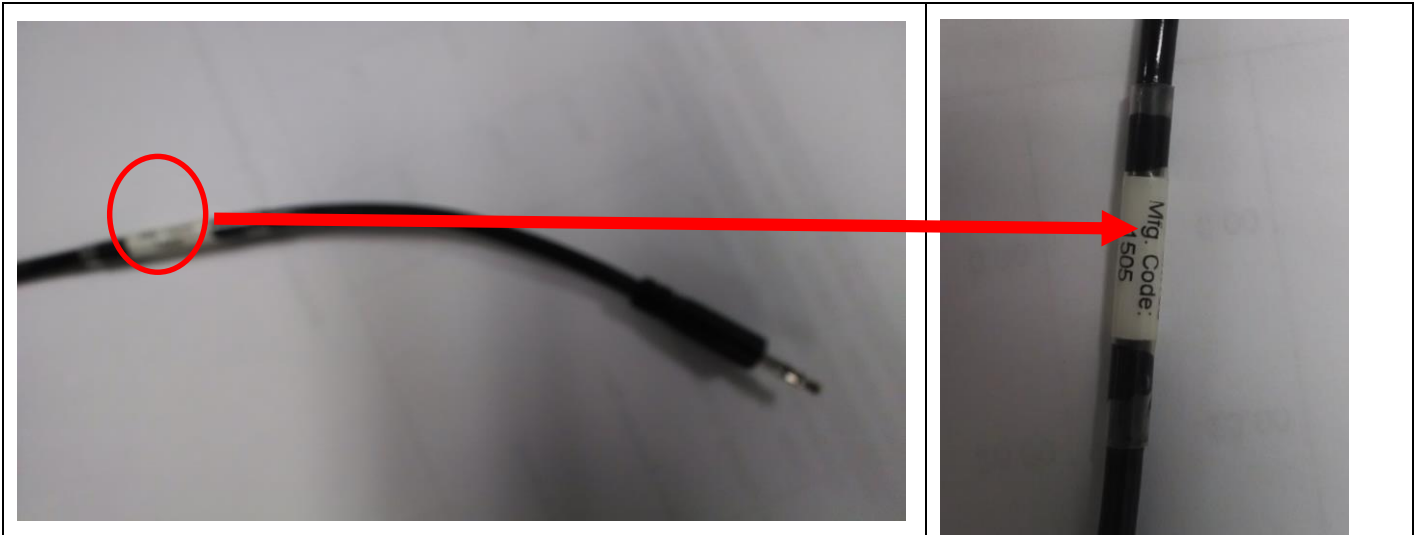
The sensors will also show MFG Code of 1505 or 1504 on the label.
