**SERVICE BULLETIN NO. 20140717**

**SUBJECT**                      **Missing GPS Information**

**PRODUCT FAMILY**        **WatchDog Sprayer Station and Console**

**AFFECTED UNITS**        WatchDog Sprayer Station with Replaceable Humidity Sensor and Console, item number 3349SSCH, consisting of items 3349SSC and 3349CN, sold between January 1, 2013 and Jul 16, 2014.

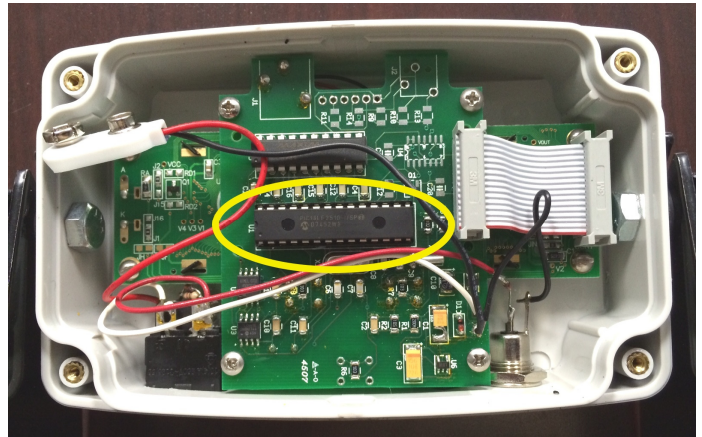
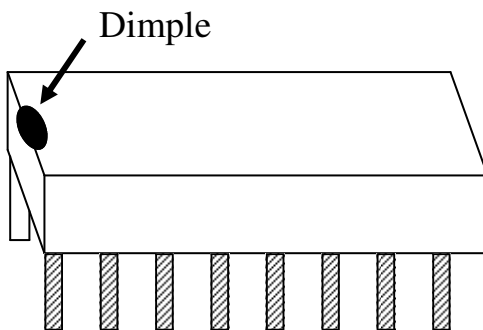
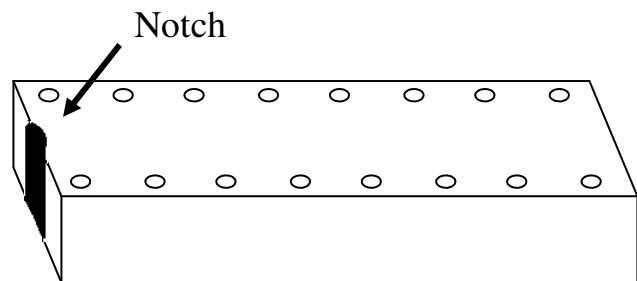
**Concern:** Due to a firmware change by the manufacturer of the GPS module component in the Sprayer Station, UTC may be reported with fractional seconds (hhmmss.ff) instead of integer seconds (hhmmss). The Sprayer Station Console, item 3349CN, was not designed to handle the fractional second format. As a result, true wind speed and direction is not reported when the vehicle is in motion.

1. Remove the Phillips-head screws from the rear cover of the console display, and lift off the cover.
2. Remove the 9 volt battery from its connector.
3. The microcontroller is located in the center. With a small screwdriver, carefully lift the chip out of the socket.
4. Identify the side of the chip with the small dimple. This should align with the side of the socket that has the notch.

5. Carefully line up the pins and the socket and press the microcontroller until it snaps into the socket.
6. Re-insert the battery and re-attach the rear cover.
